Final Site Characterization Report for Closure of Building 659 Polychlorinated Biphenyls Storage Area

14 March 1997

**FINAL SITE CHARACTERIZATION REPORT
FOR
CLOSURE OF BUILDING 659
POLYCHLORINATED BIPHENYLS STORAGE AREA
TOOELE ARMY DEPOT, UTAH**

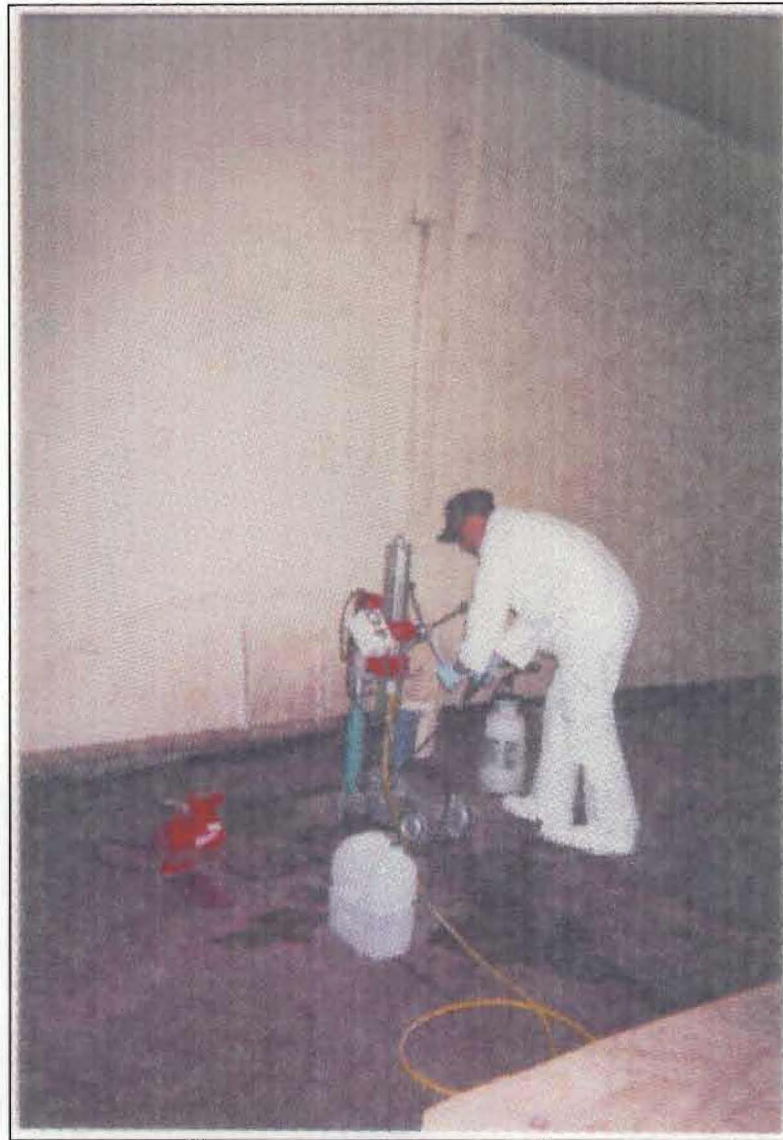
PHOTO 1. Typical Concrete Core Sample Being Cut.

Using a concrete corer that had undergone the four-step decontamination process outlined below in Section 2.5.2, the concrete was cored to approximately one quarter-inch deep. Using a decontaminated stainless steel crowbar, the core sample was removed and placed into the proper glass container. The container was double bagged and placed into the sample cooler with ice to ensure a temperature of 4 degrees centigrade (°C). At that time all sample information was completed on the sample label, chain-of-custody (COC) form, and in the project field logbook.

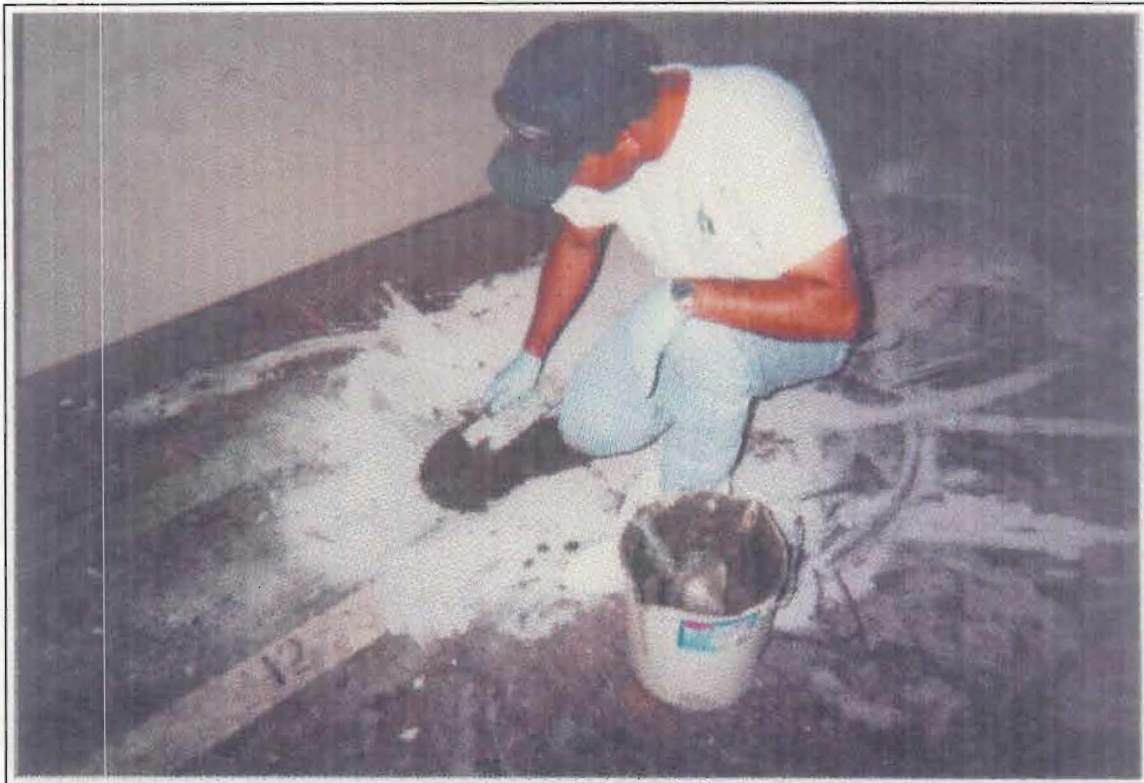
PHOTO 2. Typical Concrete Core Sample Being Restored.

The holes created by the concrete core and wood chip sampling in the storage areas were patched and repaired.

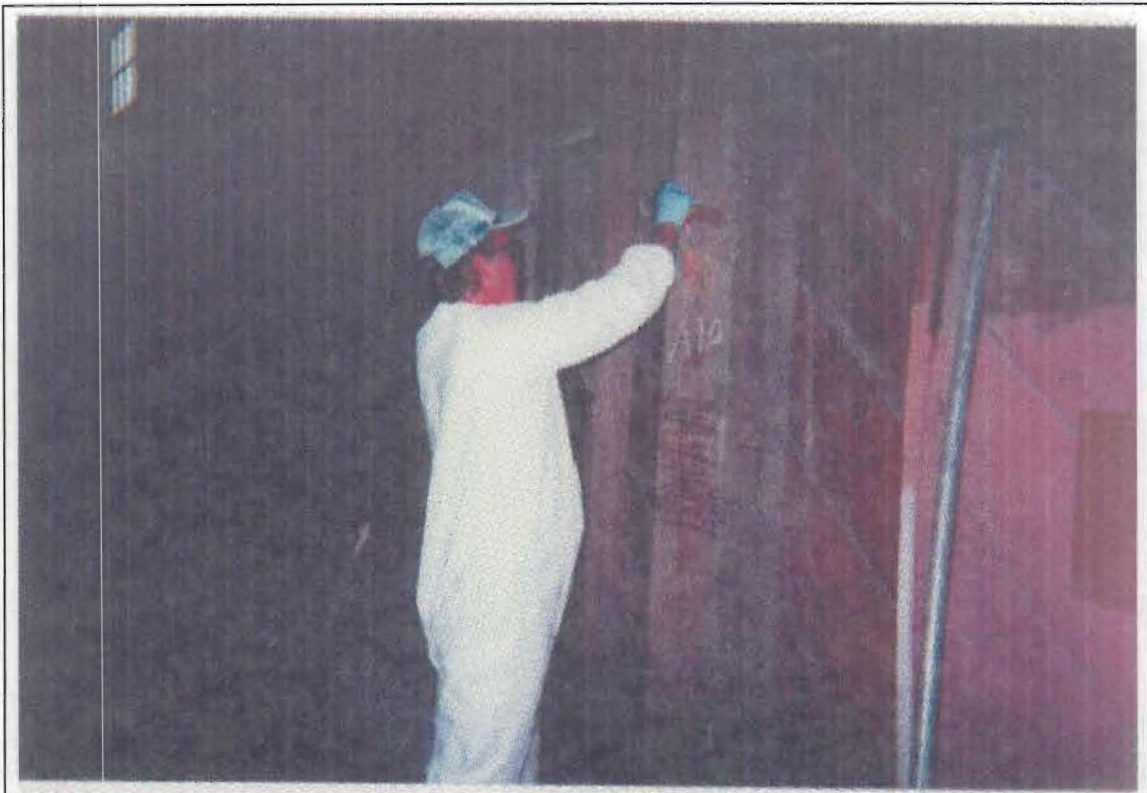
PHOTO 4. Wood Chip Sampling

Using a stainless steel chisel that had undergone the four-step decontamination process outlined below in Section 2.5.2, a piece of masonry or wood was chipped approximately one quarter inch-deep. The masonry or wood chip sample was placed into the proper glass container. The container was double bagged and placed into the sample cooler with ice to ensure a temperature of 4°C. At that time, all sample information was completed on the sample label, COC form and in the project field logbook.

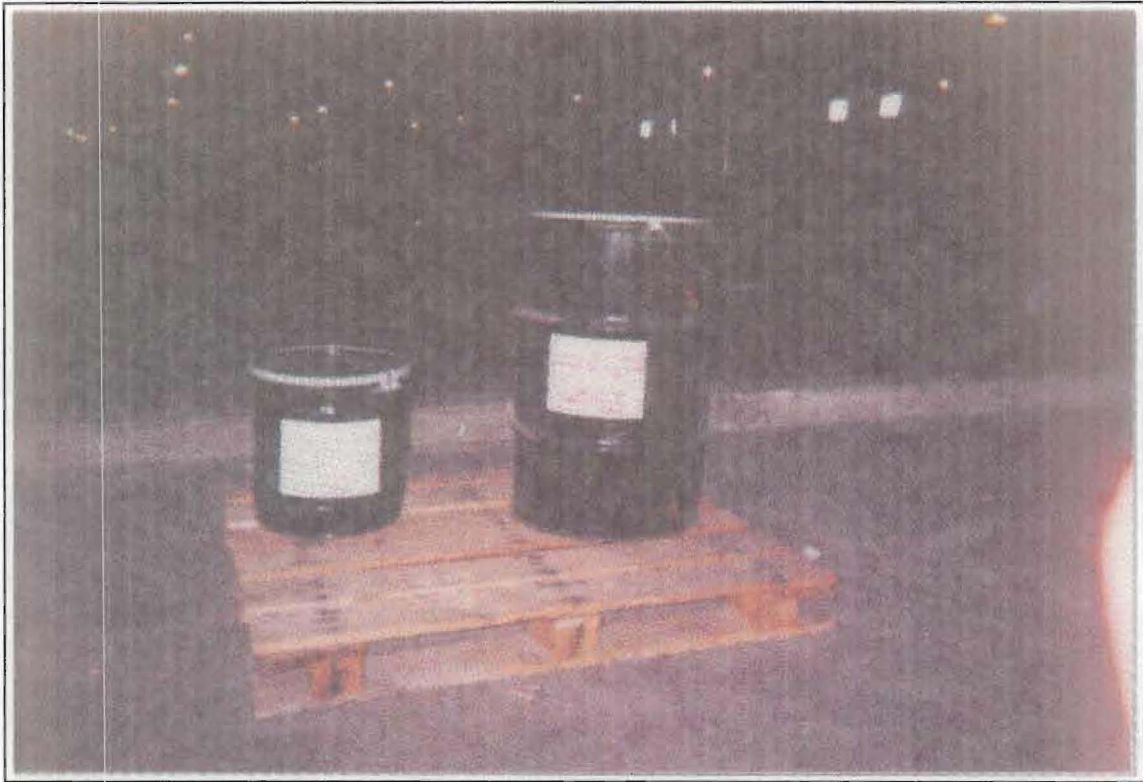
PHOTO 6. Final Containment of Project-Generated PCB Area Waste and Decontaminated Water.
